## Department of Energy

The purpose of this letter is to report the Department of Energy's (DOE) closure of the electrical safety issues at our Plutonium Finishing Plant (PFP) and at Hanford tank farms identified in your September 17, 2008, letter to the Assistant Secretary for Environmental Management.

# Richland Operations Office Plutonium Finishing Plant Closure Project

Electrical Safety DNFSB Briefing  
December 4, 2008  
Matt McCormick, RL  
Kathleen Jennings-Mills, CHPRC

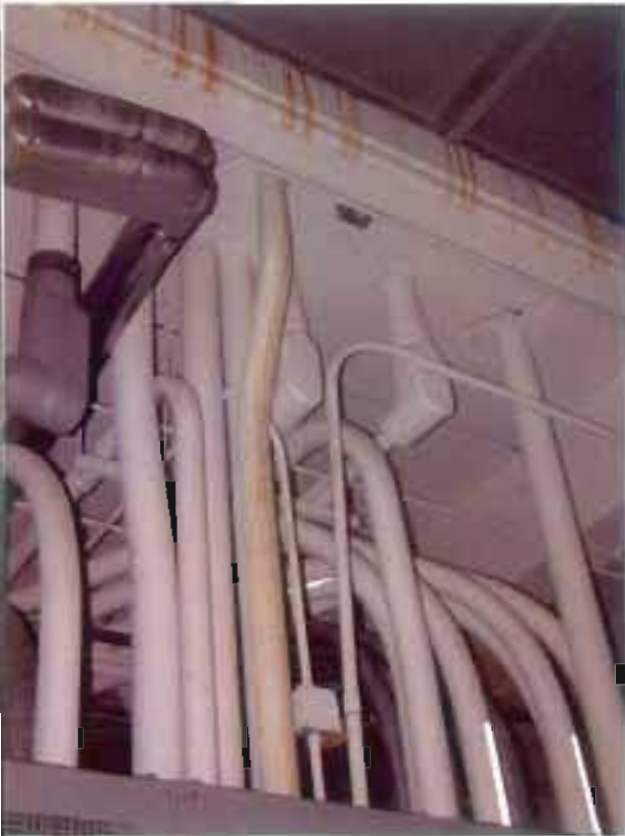
*Concern: Water could have leaked inside the switchgear. PFP agreed to evaluate the switchgear for damage.*

- **Switchgear inspected for damage, June 2008 (see photo's)**
  - No indications of damage were found
  - Water stains occurred several years ago during maintenance activities
  - Roofing inspections were conducted in July and November 2008
  - Removed water stains and painted to detect any future leaks, completed September 2008
  - Identified water leaks are being sealed (currently underway)

Conduits at 291-Z switchgear showing evidence of past water exposure

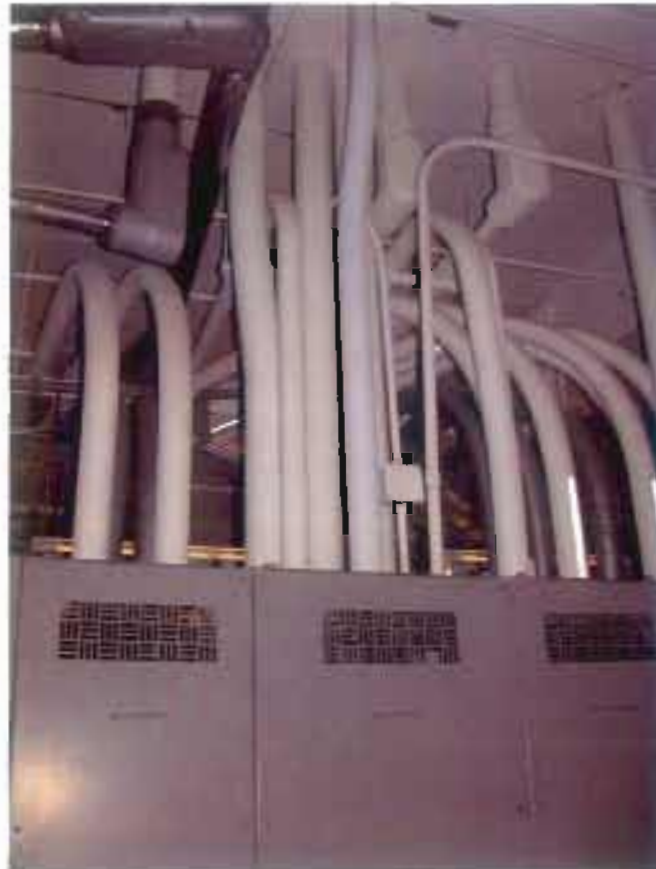
Rear of 291-Z electrical enclosure after repainting

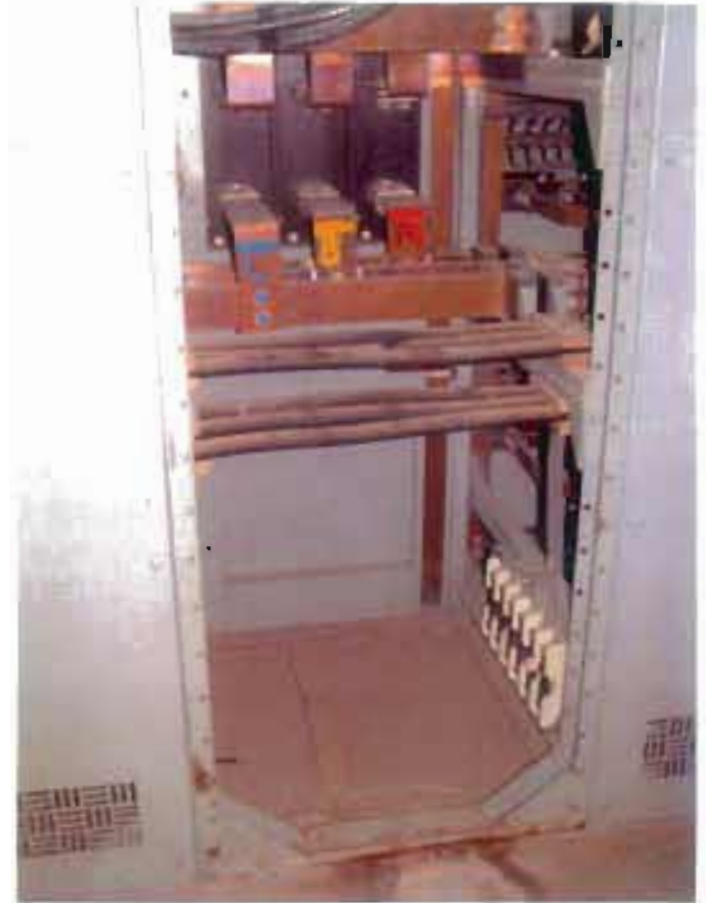
291-Z Switchgear enclosure. Lower panel below water stains

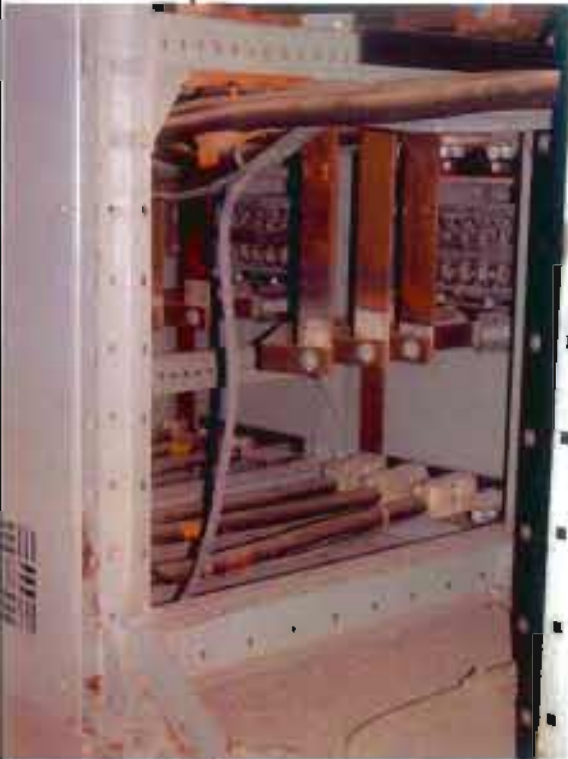
Lower panel interior close-up - left

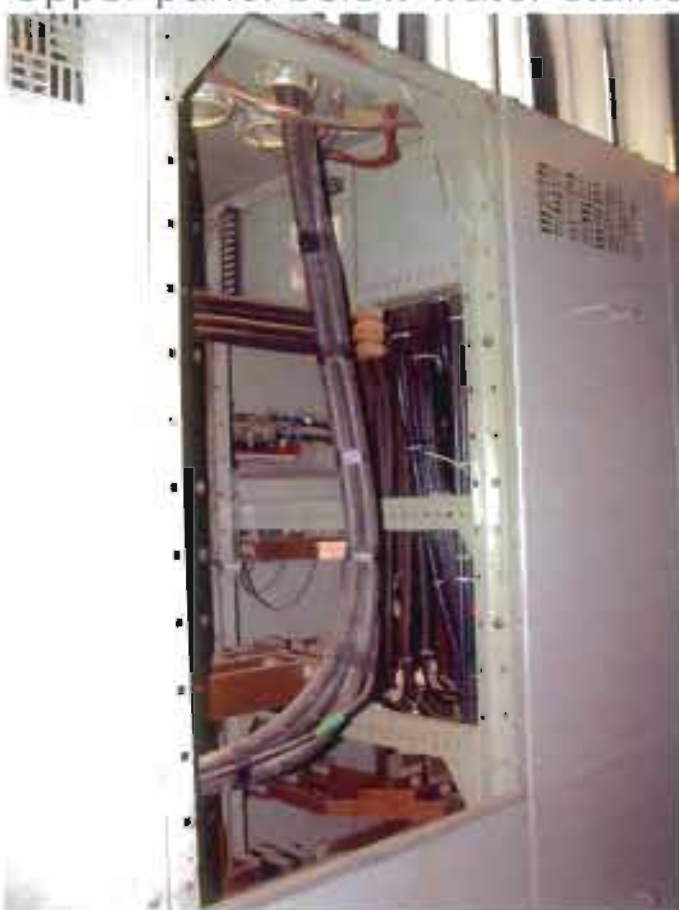
291-Z Switchgear enclosure. Upper panel below water stains

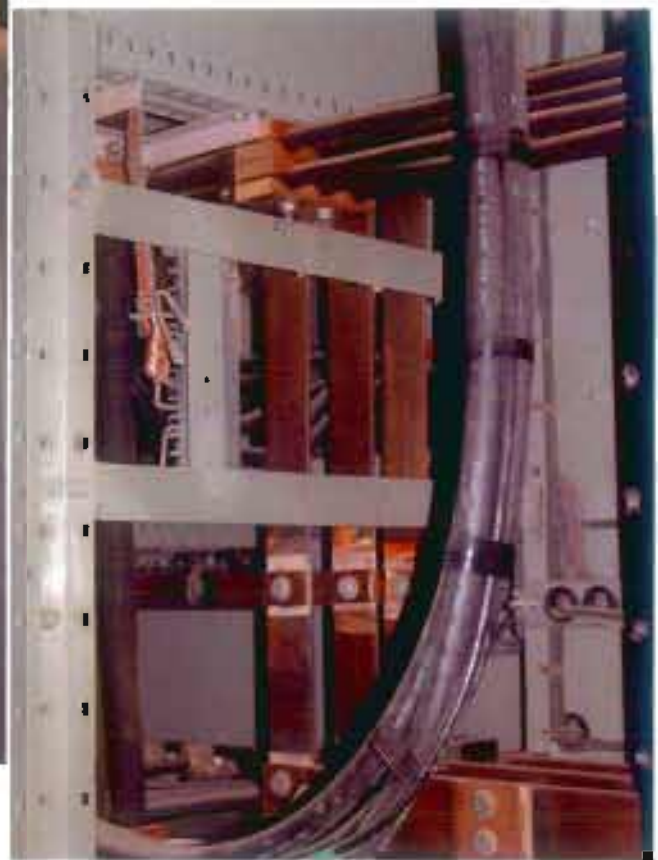
Lower panel interior close-up - right

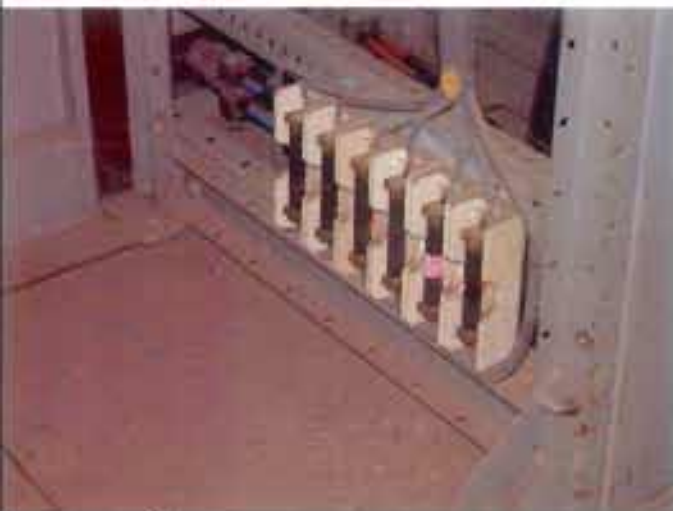
291-Z Switchgear enclosure. Upper panel interior close-up - left

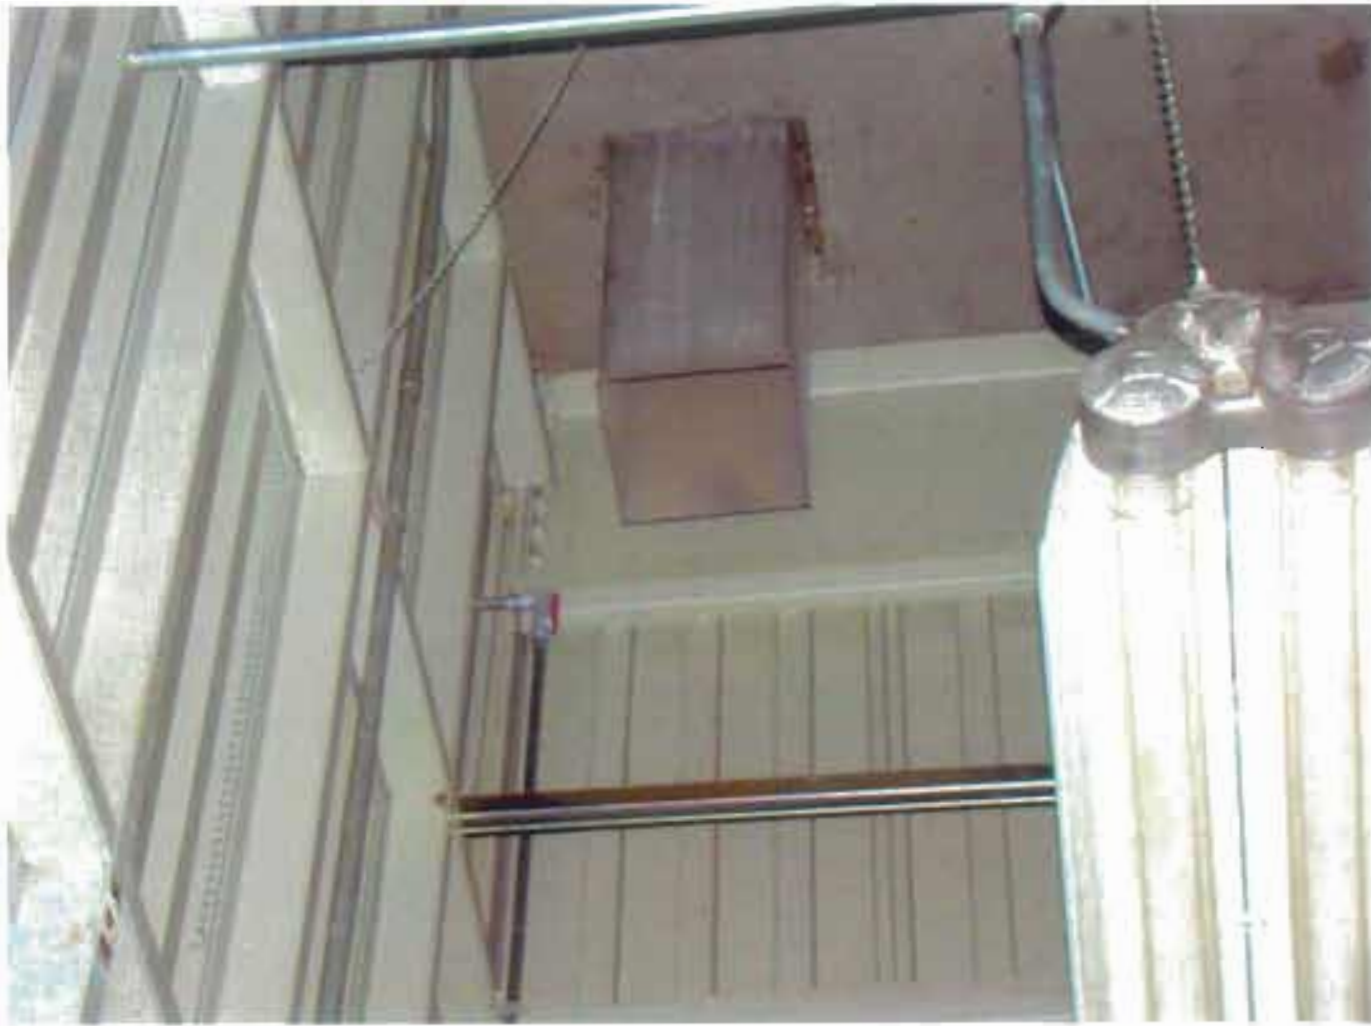
## Room 269 HVAC Duct

*Concern: PFP evaluate design modifications to prevent hydrogen accumulation in the space between the duct and the ceiling in room 269.*

- Hydrogen accumulation surveys, August 2008
  - No flammable gas detected
- Ventilation exchange rate survey, August 2008
  - High exchange rate
  - Active ventilation between duct and ceiling
- Low Hydrogen generation from batteries, per manufactures information
- Annunciation in 321 Control Room upon charging system failure
- Regularly scheduled checks of batteries (electrolyte, cell voltage, charging system, etc.) are conducted

**Modifications are not needed to prevent accumulation of hydrogen in room 269.**

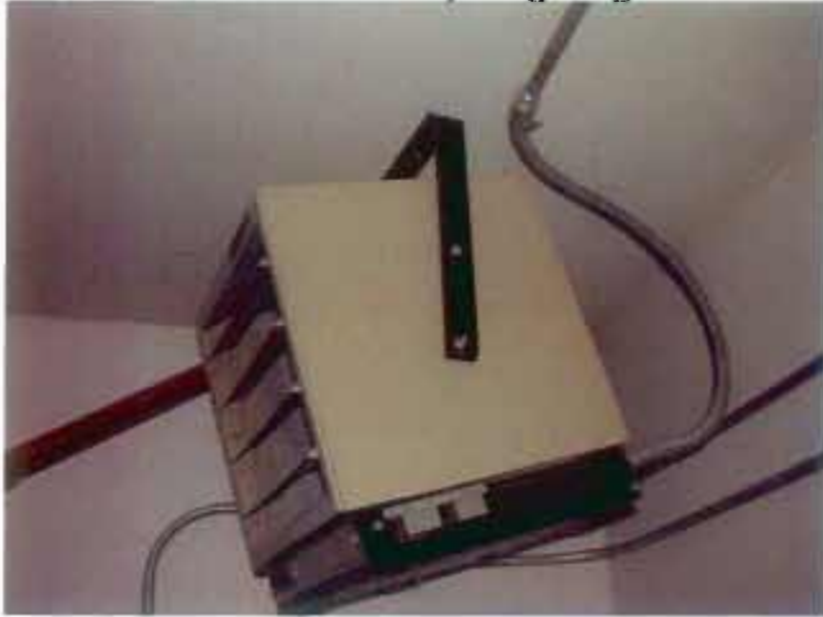
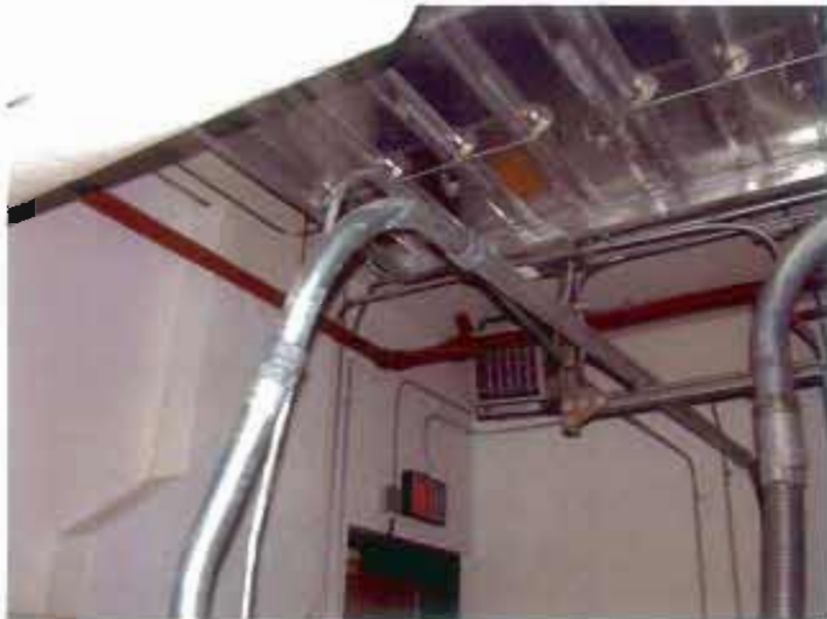
*Concern: Open-filament space heater above lead-acid batteries in the diesel generator room.  
An explosion could result if hydrogen of sufficient concentration were to come in contact  
with the open filament of the space heater.*

- Heating element maximum surface temperature is below Hydrogen autoignition temperature
- Survey of ventilation exchange rate, August 2008
  - High passive exchange rate
  - Ventilation pathways above heater elevation
- Low Hydrogen liberation from batteries
  - Regularly scheduled checks of batteries (electrolyte, cell voltage, charging system, etc.) are conducted
  - Micon annunciation upon charging system failure

2721-Z heater - angled mounting prevents accumulation of hydrogen gas

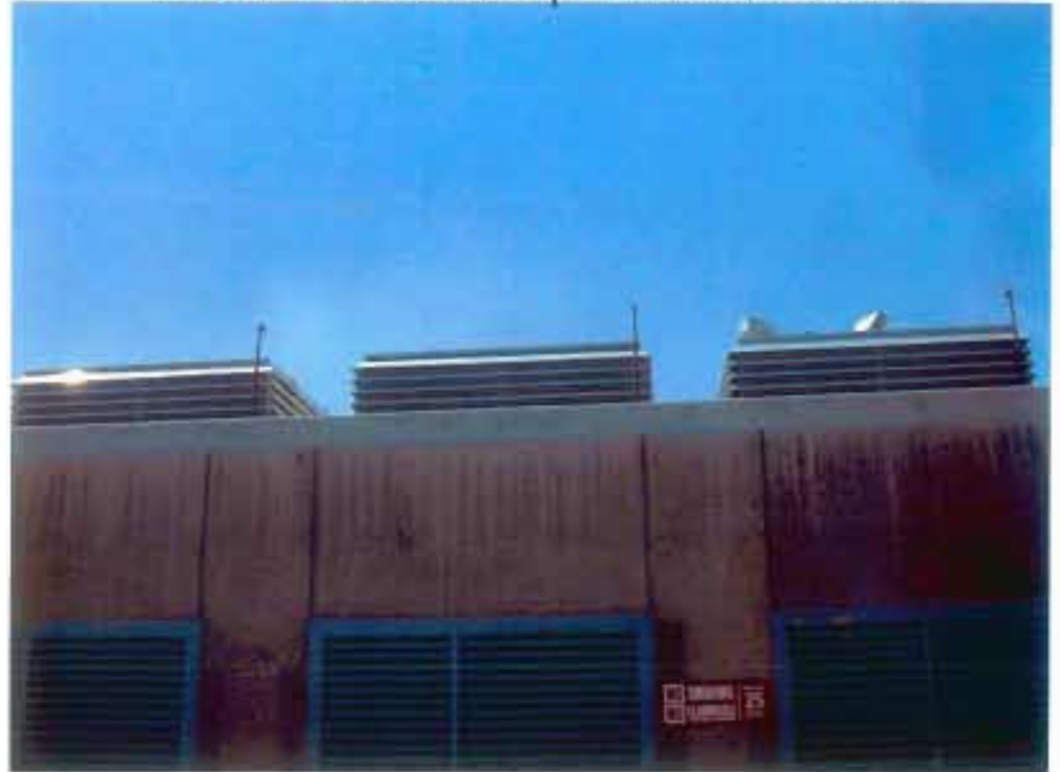
2721-Z inlet and penthouse vents
