**DEFENSE NUCLEAR FACILITIES
SAFETY BOARD**

Staff Issue Report

SUBJECT: Review of the System Back Out Plan and Ventilation System for the Plutonium Finishing Plant Project

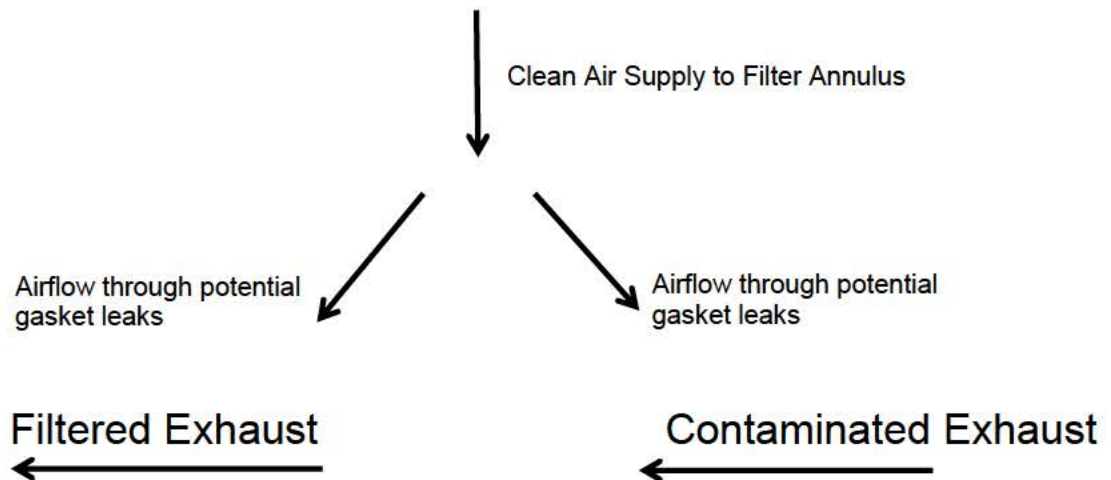
Figure 1. PFP HEPA Filter Design

The PFP HEPA filter plenum includes a unique capability to mitigate the effects of potential leakage around the HEPA gaskets that seal the filter to the plenum (see Figure 1). The design includes a gasket on the up and downstream faces of each filter, creating an annular space around the filter case. For ~45 years, a separate air supply system provided the annular space with clean, pressurized air to ensure that any gasket leaks resulted in the flow of clean air into the filter plenum rather than the flow of contaminated exhaust air around the filter gaskets. In the mid-1990s, PFP personnel terminated operation of the system's supply fan due to high vibration. The supply system continued to operate passively, relying on the negative pressure in the filter plenum to pull clean air from the supply system through any gasket leaks. Over time, the HEPA gasket seals deteriorated and flow through the supply system increased. Recent repairs and changes in damper position have reduced the flow through the system to a negligible level.

The PFP TSR requires an annual aerosol leak test of the HEPA filters to ensure that leakage around or through the filters remains within the limits prescribed by the safety basis. The review team questioned the adequacy of the leak test to detect leakage around the filters given their unique design. Specifically, because the supply system communicating with the annular space around the filters provides clean air to any leak sites, the aerosol leak test would not be capable of detecting a potential leak path around the filters (i.e., the influx of clean air

would preclude test aerosol from leaking past the gaskets). The only indication available to detect HEPA gasket degradation, and thus the potential for bypass leakage, is a differential pressure gauge on the supply system that provides a crude estimate of the airflow leaking through the gaskets into the filter plenum. The TSR, however, does not establish requirements to monitor this flow. Consequently, the review team concluded that the TSR does not establish an adequate surveillance for confirming HEPA filter operability.

The review team expressed further concern that the system configuration could lead to an unanalyzed bypass leakage condition during accidents that result in high filter loading such as a major fire. As HEPA filters load with particulate during an accident, the ventilation control system maintains the pressure upstream of the HEPA filters constant while the pressure downstream becomes more negative. The increasing pressure drop across the HEPA filters could facilitate a bypass leakage pathway around the filters if the gaskets are not leak tight and the leakage through the downstream gasket is sufficient to draw the annular space negative with respect to the plenum upstream of the HEPA filters.

The review team acknowledges that significant dilution would be expected for any bypass leakage due to the elevated release from PFP's stack. However, the review team concluded that the bypass scenario could challenge the efficiency credited in the DSA for the safety-significant HEPA filters. CHPRC and DOE-RL personnel did not disagree with this concern. Before committing to address it, they are reviewing previous technical analyses that they believe evaluated potential bypass leakage pathways. They committed to providing the staff with the results of their investigation upon completion.
