SOUTHWEST RESEARCH AND INFORMATION CENTER

RE: DOE Order 140.1

Statement by George Anastas on Behalf of Southwest Research and Information Center Relating to

NOTICE OF INTENT TO APPROVE A CLASS 3 MODIFICATION TO CLARIFY TRU MIXED WASTE DISPOSAL VOLUME REPORTING AT THE WASTE ISOLATION PILOT PLANT (WIPP) CARLSBAD, NEW MEXICO Facility Name: Waste Isolation Pilot Plant

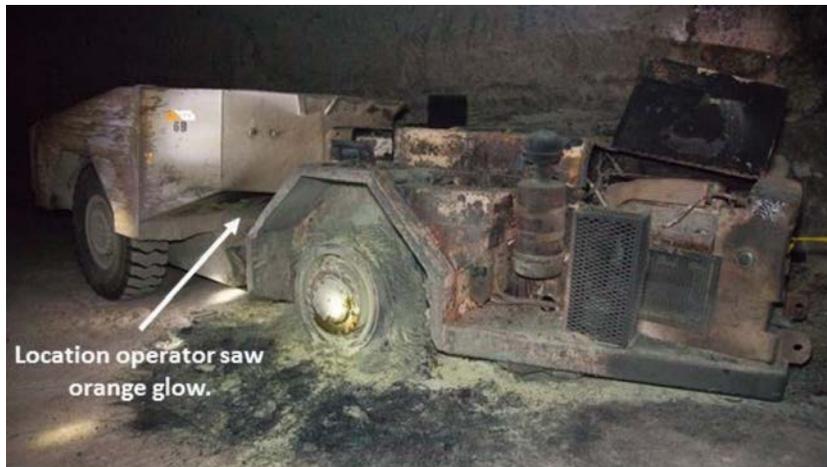
“The fire is believed to have originated in the truck’s engine compartment and involved hydraulic fluid and/or diesel fuel which contacted hot surfaces on the truck, possibly the catalytic converter, and then ignited. The fire burned the engine compartment and consumed the front tires, contributing significantly to the amount of smoke and soot in the underground.”

Salt Truck after the fire (Source: DOE)

“The (DOE Investigation) Board identified the root cause of this fire to be the failure of Nuclear Waste Partnership LLC (NWP) and the previous management and operations (M&O) contractor to adequately recognize and

mitigate the hazard presented by fire in the underground. This includes recognition and removal of the buildup of combustibles through inspections and periodic preventative maintenance (i.e. cleaning up), and the unwise decision to deactivate the automatic salt truck onboard fire suppression system.”

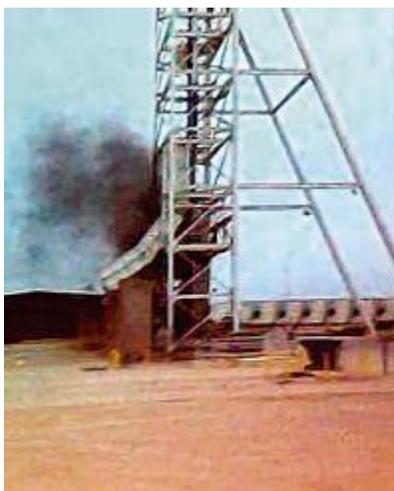
“(T) the Facility Shift Manager (FSM) directed the CMRO (ed. Central Monitoring Room Operator) to switch the ventilation system from normal to filtration mode believing this would reduce both the fire and smoke in the underground. However, this resulted in the flow of smoke into areas of the underground, which the workers expected to have “good” air. Eighty-six workers were in the underground and a total of 13 workers were treated; six transported to a local hospital and seven treated on-site.”

Smoke from the smoke truck fire billowing out the salt shaft! (Source: WordPress.com)

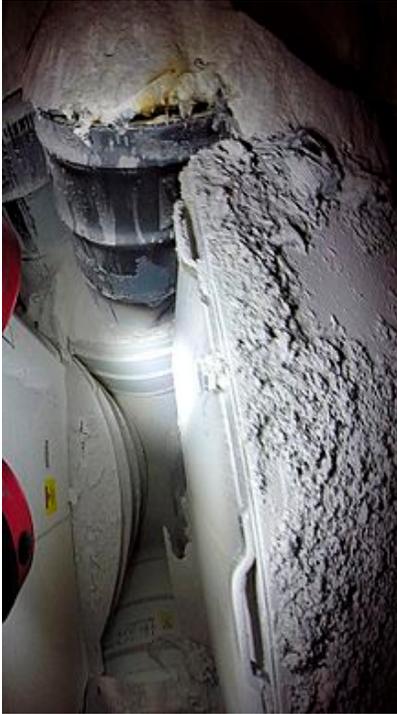
LANL Waste Drum 68660 after detonation deep inside WIPP resulting in over \$1,000,000,000 and a multi-year shutdown of WIPP (source: DOE)

On February 14, 2014, an incident in Panel 7 Room 7 (P7R7) of the Waste Isolation Pilot Plant (WIPP) underground repository resulted in the release of radioactive material (predominately Am-241, Pu-239, Pu-240 and Pu-241) into the environment and contaminated 22 people with low-level radioactivity.

The (DOE) Technical Assessment Team (TAT) concluded that one drum, Drum 68660, was the source of the radioactive contamination released in the February 14, 2014, radiological event. The contents of Drum 68660 were chemically incompatible, and the drum breached as a result of internal chemical reactions.

The TAT concluded that chemically incompatible contents in Drum 68660, in addition to the configuration of materials in the drum, supported exothermic chemical reactions that led to a thermal runaway. In other words, a series of ever-increasing heat-releasing reactions occurred, which led to the creation of gases within the drum. The resulting build-up of gases within the drum displaced the drum lid, venting radioactive material and hot matter that further reacted with the air or other materials outside the drum to cause the observed damage in P7R7 of WIPP.
