**DEFENSE NUCLEAR FACILITIES
SAFETY BOARD**

Staff Report

Review of the Safety Instrumented Alarm System (SIAS) Failure at the Waste Isolation Pilot Plant (WIPP) on December 9, 2018.

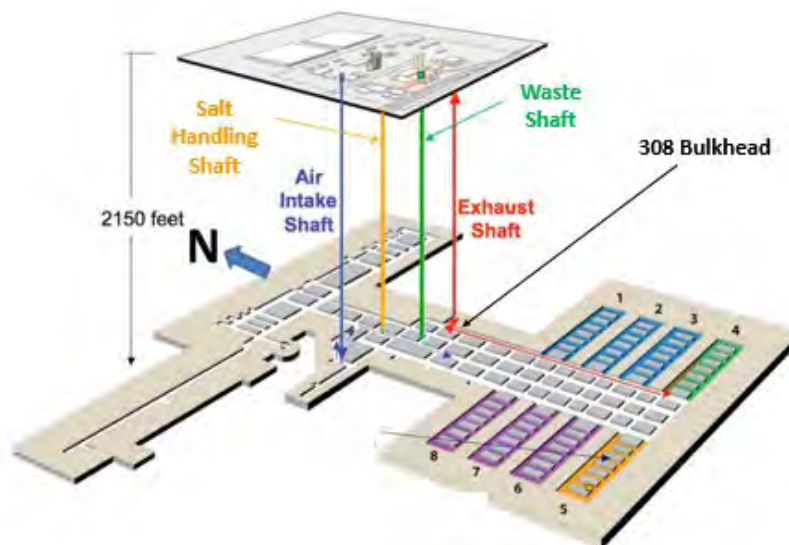
Figure 1. *WIPP Underground Ventilation*

In referring to Figure 1, the original underground ventilation system (UVS) design was for air to enter the underground from the air intake shaft, the salt handling shaft, and the waste shaft. The air would be distributed in the underground and exhausted through the exhaust shaft unfiltered. The ventilation system was designed to switch to filtered exhaust upon detection of an underground radiological release.

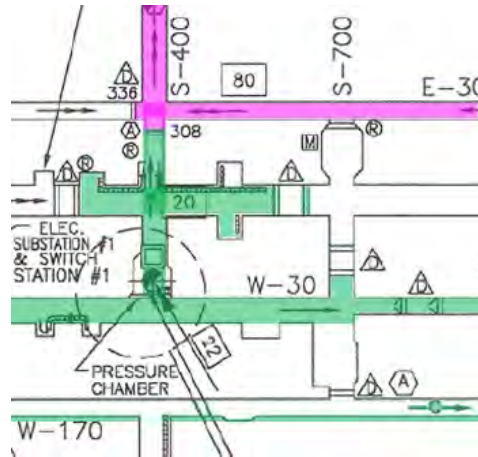
Figure 2. Bulkhead 308

In referring to Figure 2, air from the waste handling building is pulled down the waste shaft and passes by Bulkhead 308 on its way through the underground and to the exhaust shaft. Green represents the clean air side of the underground coming from the salt handling shaft and the waste shaft. Magenta represents the potentially contaminated exhaust air side going to the exhaust shaft.

If the dP across Bulkhead 308 is sufficiently higher on the clean side of the S-400 cross drift² then air will go up the exhaust shaft. Assuming all else in the exhaust circuit is working as designed then any airborne contamination in the disposal panel will also be sucked up the exhaust shaft and not leak into other areas where it could be released to the environment through other shafts, e.g., the salt handling shaft.
