**DEFENSE NUCLEAR FACILITIES  
SAFETY BOARD**

### Staff Report

#### **Review of the Safety Instrumented Alarm System (SIAS) Failure at the Waste Isolation Pilot Plant (WIPP) on December 9, 2018.**

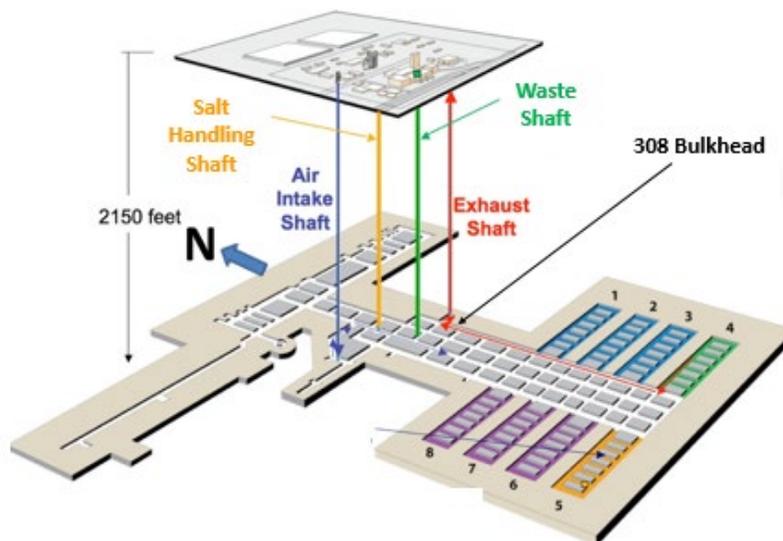
**Figure 1.** *WIPP Underground Ventilation*

In referring to Figure 1, the original underground ventilation system (UVS) design was for air to enter the underground from the air intake shaft, the salt handling shaft, and the waste shaft. The air would be distributed in the underground and exhausted through the exhaust shaft unfiltered. The ventilation system was designed to switch to filtered exhaust upon detection of an underground radiological release.

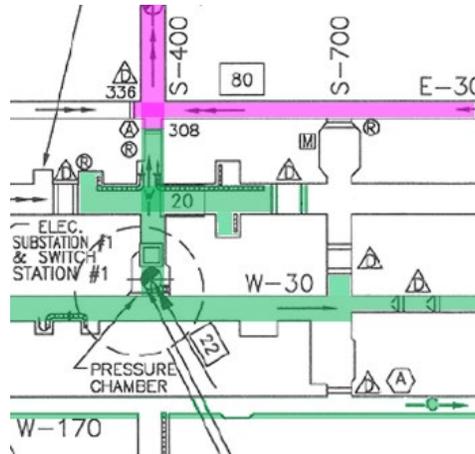
**Figure 2.** Bulkhead 308

In referring to Figure 2, air from the waste handling building is pulled down the waste shaft and passes by Bulkhead 308 on its way through the underground and to the exhaust shaft. Green represents the clean air side of the underground coming from the salt handling shaft and the waste shaft. Magenta represents the potentially contaminated exhaust air side going to the exhaust shaft.

If the dP across Bulkhead 308 is sufficiently higher on the clean side of the S-400 cross drift<sup>2</sup> then air will go up the exhaust shaft. Assuming all else in the exhaust circuit is working as designed then any airborne contamination in the disposal panel will also be sucked up the exhaust shaft and not leak into other areas where it could be released to the environment through other shafts, e.g., the salt handling shaft.
