**DEFENSE NUCLEAR FACILITIES
SAFETY BOARD**

Staff Report

Reactive Materials Hazard Review at the Y-12 National Security Complex

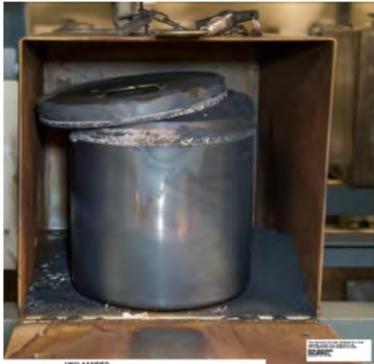
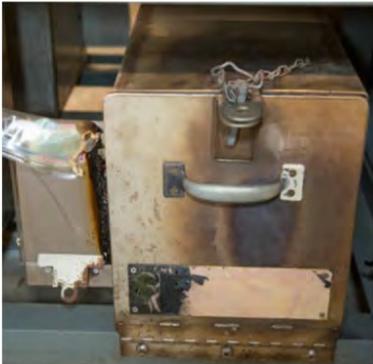
Figure 2. *Briquette Thermal Runaway Reaction Event in Storage at Y-12*

The seven events in Table 1 demonstrates that different uranium physical forms (chips, briquettes, or buttons) generated at Y-12 can undergo a thermal runaway reaction. The event in the DNFSB resident inspector activity report for the week ending on June 30, 2017 [16], shown in Figure 2 is an example of a severe thermal runaway reaction that could have caused significant injury to a facility worker if one had been present.

June 30, 2017	Exothermic reactions of multiple cans containing briquettes.	Fire department used thermal imaging to verify storage box was at ambient temperature before opening. Operators opened storage box and observed containers were burned and the tape seal melted.

Inner container with briquette

Outer lock box

Y-12 should improve its control strategies to prevent and mitigate uranium pyrophoric hazards and identify thermal runaway uranium reactions with sudden energy release as an initiating event for fire in its safety bases. An improved hazard analysis and control strategy could be used to reduce the likelihood of (i.e., prevent) and ensure appropriate response to (i.e., mitigate) pyrophoric events. This should include improved procedures and training to ensure responses to pyrophoric events are consistent with the guidance in DOE-HDBK-1081-2014 [7] throughout the enriched uranium processes.
