DEFENSE NUCLEAR FACILITIES SAFETY BOARD

MEMORANDUM FOR: G.W. Cunningham, Technical Director
FROM: T. Dwyer and H. Waugh, Pantex Site Representatives
SUBJECT: Pantex Plant Activity Report for Week Ending June 26, 1998

Attachment 1
Occurrence Report ALO-AO-MHSM-PANTEX-1998-048:
Information Supplement

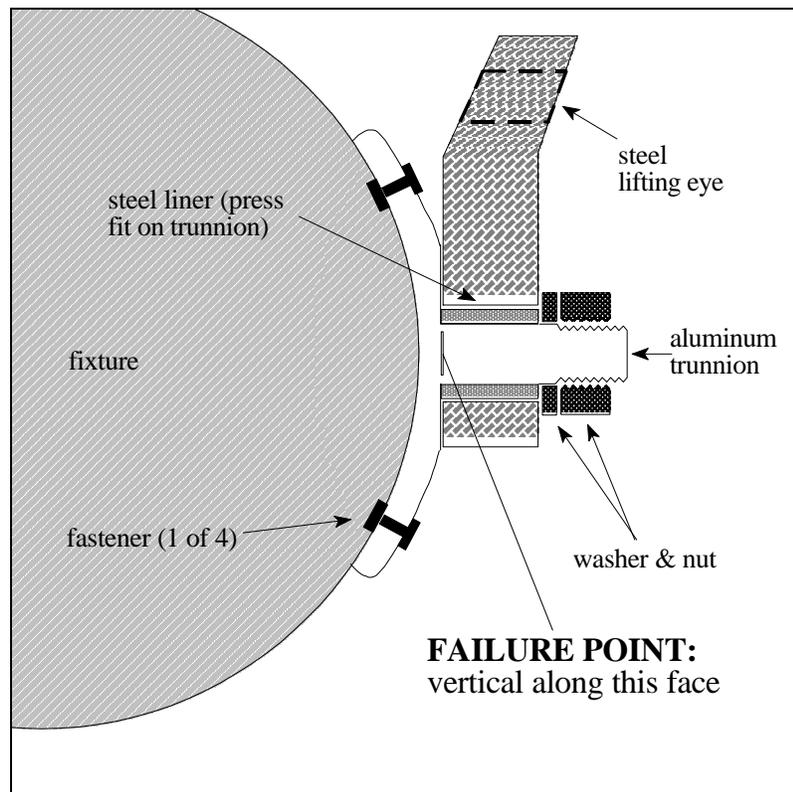
Detail: Al Trunnion for Lifting & Rotating W88 MOI Fixture

Description of Part: A rough drawing of the point of failure is provided, facing the fixture end-on (looking lengthwise down a unit). The trunnion bolt flares from a threaded 1-inch diameter shaft to a mounting flange. The trunnion bolt/flange is a single piece of 6061 aluminum. Four fasteners penetrate the flange in 2 rows of 2, securing the trunnion bolt to the fixture. A hardened steel liner (wear ring) is press-fit over the trunnion bolt. A hardened steel lifting eye then slides over the liner with several mils clearance. This allows the fixture and the eye to rotate relative to each other. Note that rotation is limited by [1] two metal stops (not shown) that preclude rotation beyond a 90° arc; and [2] a hand-operated quick release pin (also not shown) that passes through the lifting eye to mate with one of two holes located in the flange at the 0° and the 90° positions.

Probable Cause(s) of the Event: Initial reports from the eyewitnesses present indicated that the trunnion bolt nearest the PT trying to pull the quick release pin suddenly failed, separating from its lifting eye, which remained on the safety hook. The fixture fell as far as the now unbalanced strongback and single steel cable would allow, then rebounded upward, forced the other lifting eye past the remaining (attached) safety hook, and completed the drop to the ground. However, it was subsequently revealed that one PT was in fact facing away from the lift, being involved with unbolting a piece of tooling from the Miller table. A second PT, responsible for handling the hoist controls, was specifically moving and then watching the various hoist controls/cables to prevent them from becoming entangled in the W88 MOI tooling fixture when it was rotated. The third PT was making his third attempt to adjust the fixture to a perfectly horizontal position so that the quick release pin could be removed. [Note that the empty fixture is slightly unbalanced and does not naturally hang horizontally.] This adjustment is performed at a height of 6 feet -- above the head of the PT. Thus, at the time of the event, two of the eyewitnesses were in fact not directly observing the fixture, while the third was so close to the fixture, as well as physically threatened by its immediate trajectory as it fell, that his recollections of the event are probably of limited value. These eyewitness' observations are disputed by subsequently developed investigative data.

Initial microscopic analysis (performed by A. Duncan, M&H) of the failed trunnion bolt face indicates that it failed in tension, not in shear or in torsion. This conclusion is supported by several independent indicators, including the following.

- [1] There is an indentation driven into the trunnion flange on the side away from the hook attachment point in the lifting eye, matching the outline of the edge of the steel liner.

- [3] The quick release pin was not pulled by the PT, but dragged out with its ball stops engaged, as indicated by markings gouged in both sides of its hole in the trunnion flange. [It remained in the broken lifting eye, hanging on the hoist, after the event.] If the trunnion bolt had failed in shear, as reported, this quick release pin has a calculated shear capacity of 4600 lbs, quite sufficient to maintain the fixture on the hoist. The calculated load necessary to pull the pin out with the ball stops engaged is 575 lbs.

Based on this initial analysis, M&H is focusing on improper hoisting and lifting as the root cause for this event. It appears that the (unfailed) lifting eye came off its hook first, the fixture began to fall, failed the remaining trunnion bolt in tension, pulled away from the quick release pin, and landed on the ground. The cause of the unfailed eye detaching is presumed to be improper or incomplete initial attachment.

Corrective Actions to Date: Given this root cause, M&H management ordered a safety stand-down to review proper hoisting and lifting procedures with every shift of PTs (completed Friday, swing shift). Until further notice, NDE Department (to whom the PTs involved report) has

suspended similar operations involving the W62 and W84. Once operations resume, the presence of a supervisor will be required for any NDE lifting operation.

In addition, although they no longer believed the root cause of this event was attributable to the specific equipment/materials in use, M&H began a review to determine if any other lifting fixtures containing aluminum shaft trunnions exist at Pantex. This trunnion bolt configuration, involving aluminum, is not common. While this review is in progress, all PTs and Operations Supervisors have been instructed to contact M&H T&MD if they observe a possible aluminum trunnion in their tooling while preparing for any hoisting and lifting operations. At least two such observations were reported. T&MD inspected the fixtures in question prior to hoisting and approved their subsequent use.
