DEFENSE NUCLEAR FACILITIES SAFETY BOARD

April 21, 1997

SUBJECT: Work Planning and Conduct of Operations at the Hanford N Basin

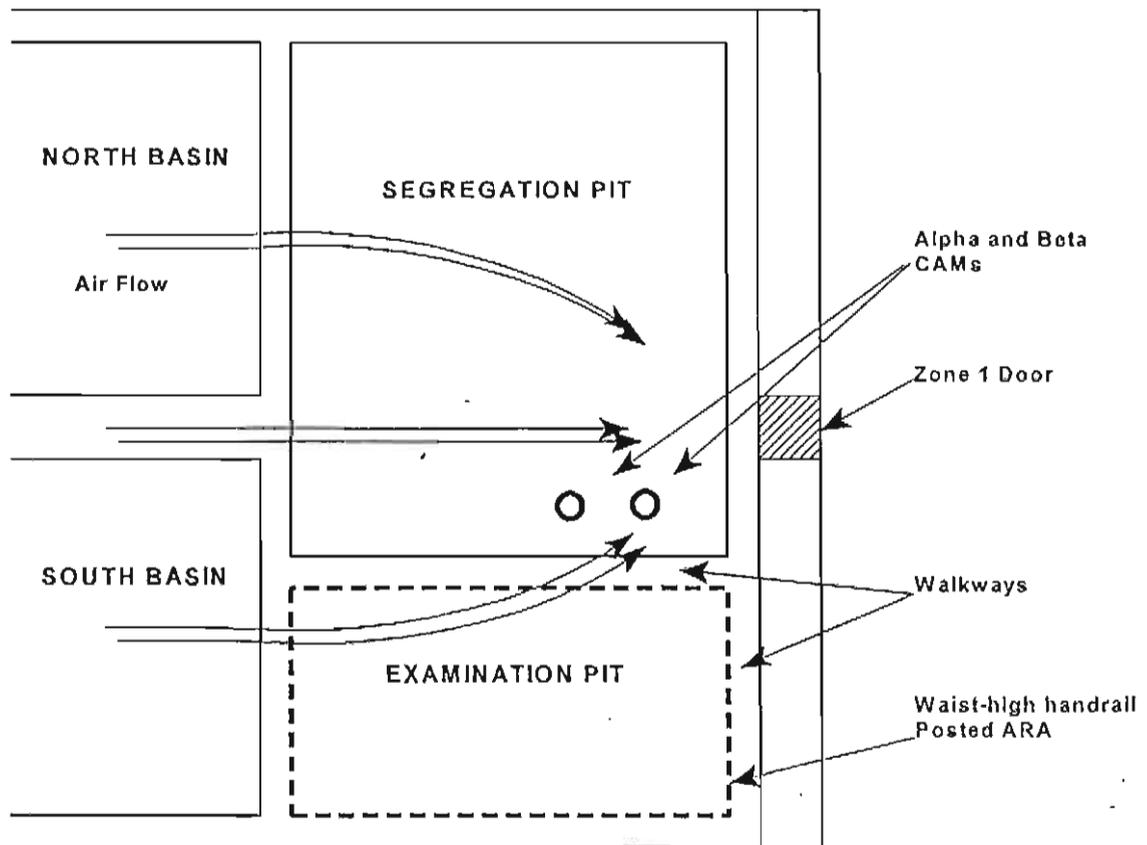
Figure 1. N Basins, East End

Airborne Radioactivity Postings. While touring the N Basin on March 27, 1997, the Board's staff observed airborne radioactivity area (ARA) postings on handrails that surrounded the Examination Pit (see Figure 1). No physical barriers separated the air space of the posted airborne area from the unposted areas. The prejob briefing for the tour did not include mention of an ARA, nor was one identified on the radiological survey map. Walkways allowed access to basin areas that surrounded the posted area.

Upon further investigation, the Board's staff learned that N Basin management had stopped the cutting work (the near-miss event) requiring the postings, but that the radiological controls (radcon) organization had not authorized downposting of the area. Air samples taken after the work, which indicated potentially high airborne contamination levels, had not had sufficient time for the radon contribution to decay. Later, the radcon organization confirmed the presence of radon and removed the ARA postings.
