DEFENSE NUCLEAR FACILITIES SAFETY BOARD

SAFETY OF HEPA FILTER UNITS IN HANFORD B-PLANT EXHAUST VENTILATION SYSTEM

April 15, 1996

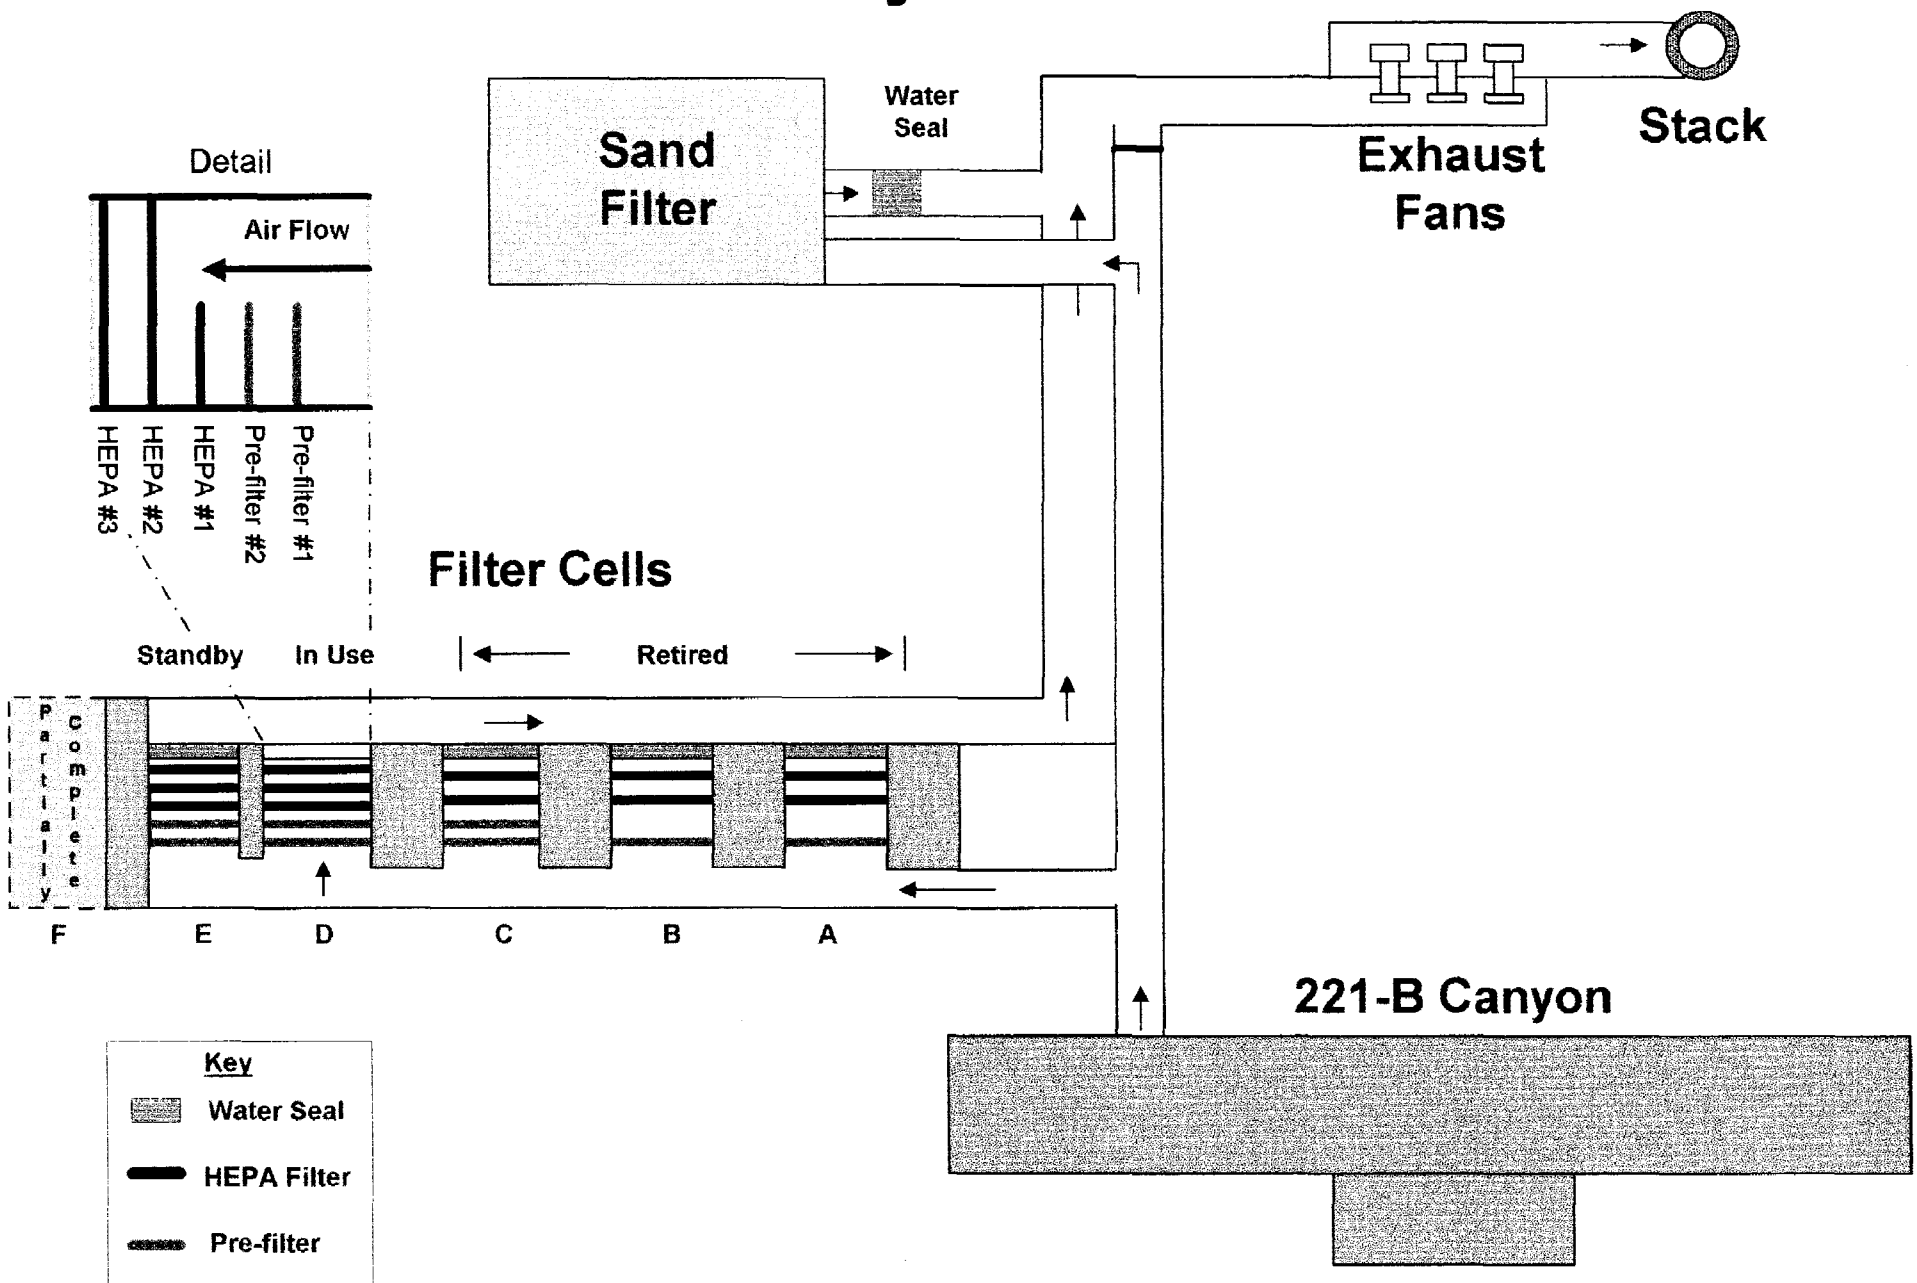
Figure 1

Ventilation System Schematic

The HEPA filter units, shown in Figure 1, are contained in separate cell structures constructed of reinforced concrete and steel. The cell structure design, shown in Figure 2, includes an outlet water seal to isolate each filter cell individually from the exhaust air stream. B- and C-Filter also have an inlet water seal. The inlet seals were to provide isolation of these filters when future filters were installed, but the isolation is now provided with a concrete plug. There is an automatic filling system which maintains the water level in the outlet water seals. The water seal levels can also be monitored and adjusted manually. The water seals of all the HEPA filter cells are now filled except for the outlet seal of the operating D-Filter. A drainage sump is also located in each filter cell to collect any overflow from the water seals.

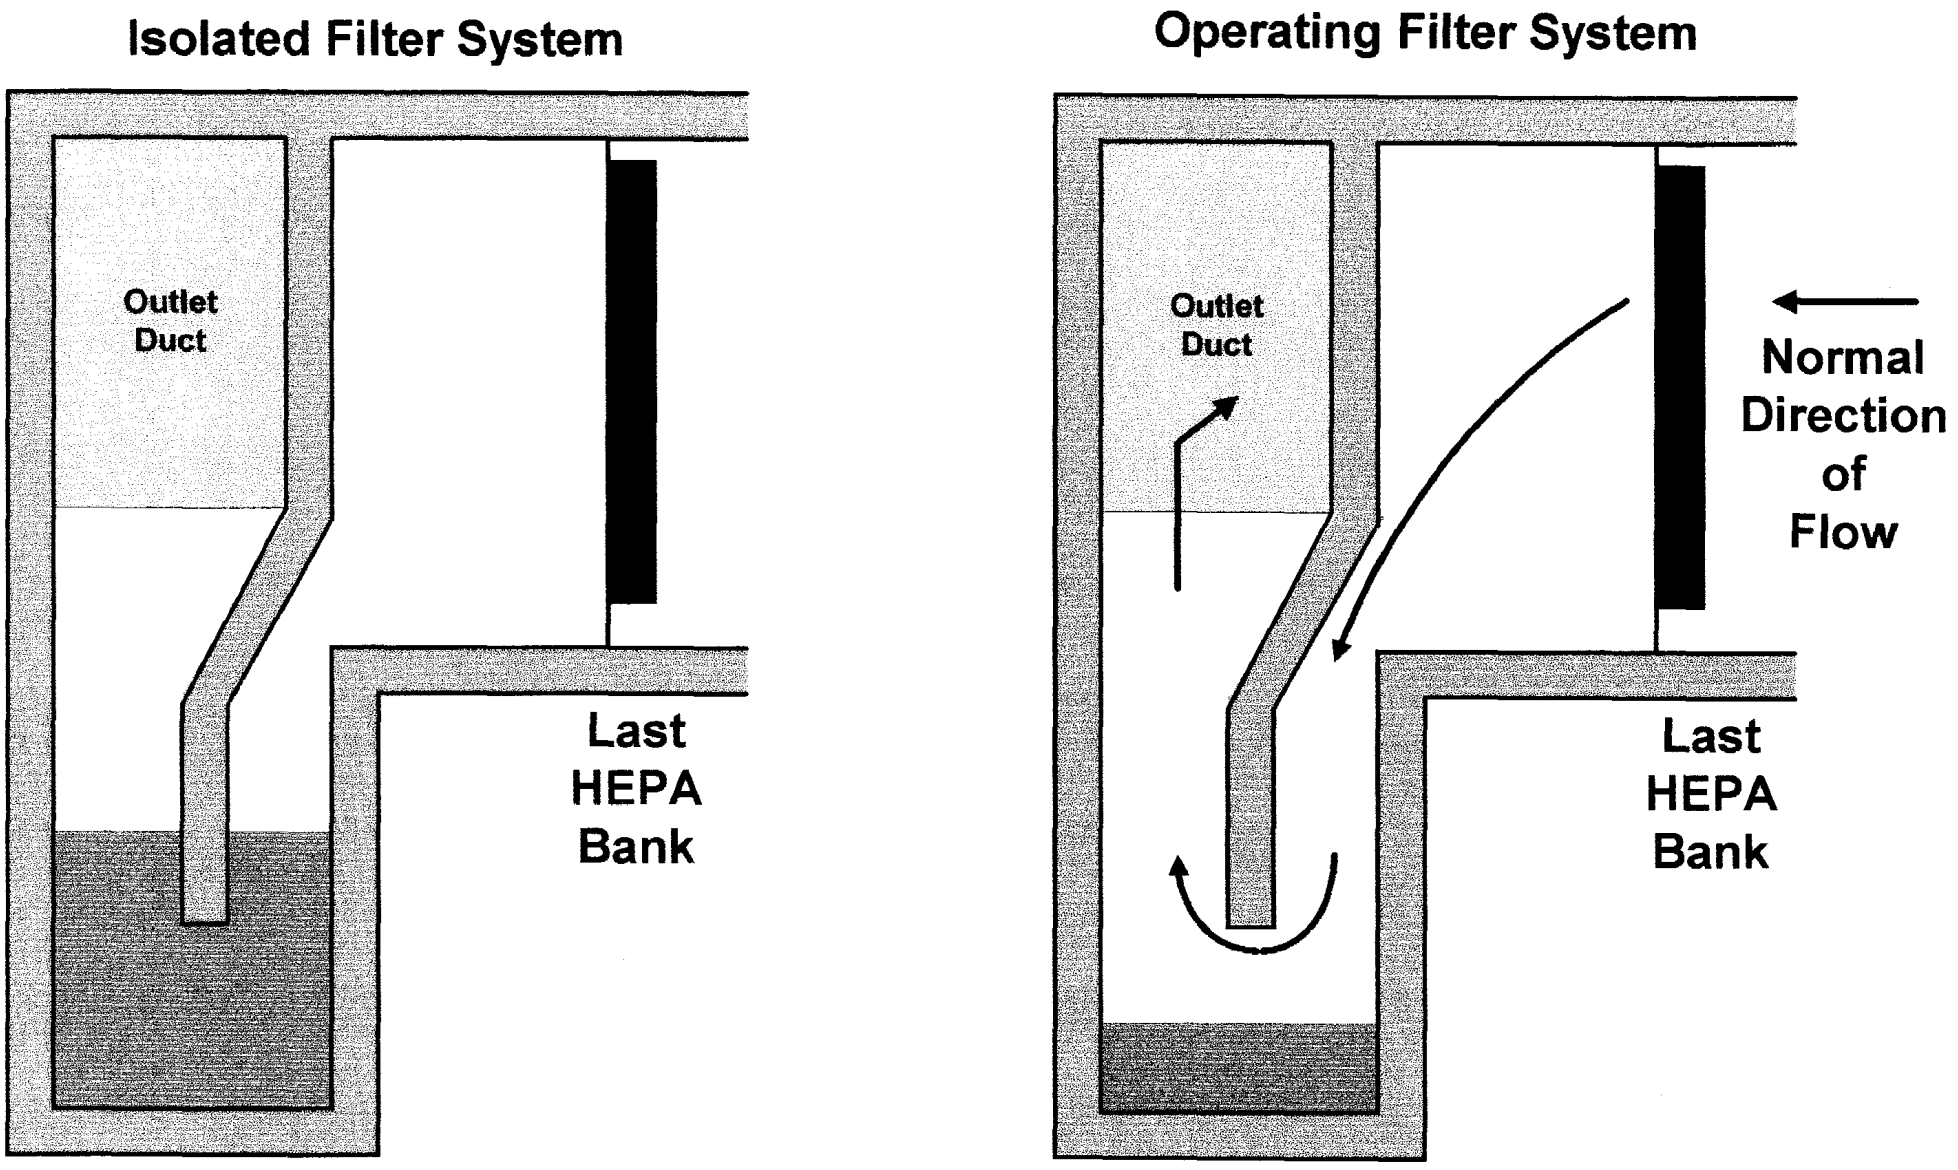
Figure 2

Outlet Water Seal Design

Although water seals may be appropriate for remotely operating inaccessible filter units, they do not provide a reliable long-term isolation function for retired or deactivated filter units. The water seals were not designed to meet single failure criteria and could be subject to inadvertent rapid draining (e.g., steam jetting) or gradual draining (e.g., evaporation, leaks). The water seals are also subject to overfilling that can flood the filter cells and wet the HEPA filters, which would further degrade the integrity of the filters. The flooding can also provide another mechanism for transport of radionuclides from the HEPA filters to the environment. As noted in Appendix A, retired filter units have been inadvertently flooded on two occasions.[22,23,24]

In the past, WHC had considered various alternative schemes for isolating HEPA filters, including grouting and use of a nonvolatile liquid or foam material. All of these alternatives were rejected, and there are no near-term plans to replace the water seals. Leaving the outlet water seals of the retired filter units in their present configuration for several more years does not appear to be prudent. It appears that additional effort is warranted to identify an alternative that would provide enhanced reliability and not adversely impact future remediation of the filters. For example, the suitability of using a fine sand should be analyzed. The sand could be pneumatically and remotely substituted for the water, would be temporary, and would not be susceptible to inadvertent jetting.
