**DEFENSE NUCLEAR FACILITIES
SAFETY BOARD**

Staff Report

Reactive Materials Hazard Review at the Y-12 National Security Complex

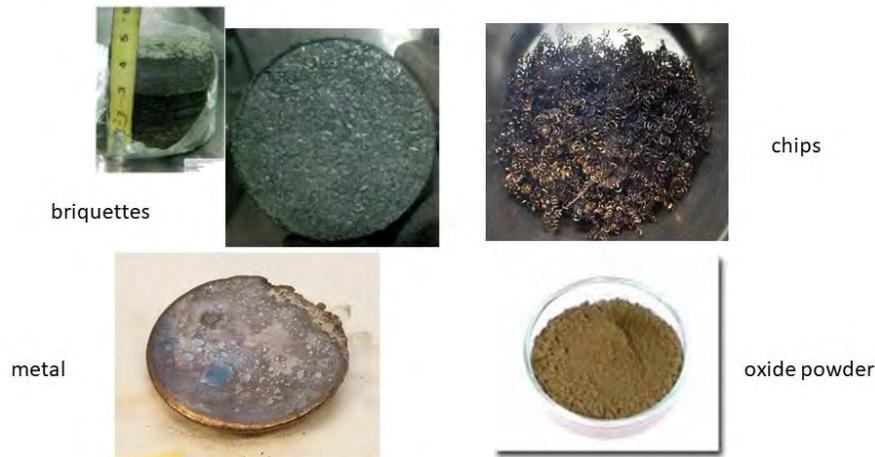
Figure 1. *Uranium Material Forms at Y-12.*

Enriched Uranium Thermal Runaway Reaction Hazards—In general, uranium is very reactive in air, particularly moist air. Enriched uranium process operations generate various uranium products that are very reactive. Figure 1 shows examples of uranium forms generated at Y-12.

These forms include chips, briquettes, metal buttons, and uranium oxide powder, whose reactivity is dependent on parameters such as: specific surface area; morphology; and oxidation kinetics. The DOE-HDBK-1081-2014, *Primer on Spontaneous Heating and Pyrophoricity*, defines a pyrophoric material as one that “even in small quantities and without an external ignition source can ignite at or below 130°F in contact with air” [7]. The handbook further states that uranium in a finely divided form (e.g., chips and powders) is pyrophoric in air. Y-12 has experienced 15 pyrophoric events in production and development facilities between 2016 and 2021 [8 – 18] due to the physical forms of uranium (Figure 1) generated during processing. Seven of those events are described in Table 1. The full list of all 15 events is provided in Appendix A.
