The purpose of this letter is to inform you of the actions taken to address the Defense Nuclear Facilities Safety Board (DNFSB) staff observations of the electrical and instrument and control systems at the Hanford Plutonium Finishing Plant.

This corrective action plan was developed to address specific issues and recommendations made by DNFSB staff for improving the electrical and instrumentation and control systems and equipment at the Plutonium Finishing Plant (PFP). RL and FH evaluations of DNFSB issues/observations concluded that the facility is operating within the approved safety authorization basis. However, opportunities exist for improvements in the reliability of PFP electrical and instrumentation and control systems.

Electrical and Instrumentation and Control Systems

Corrective Action Plan

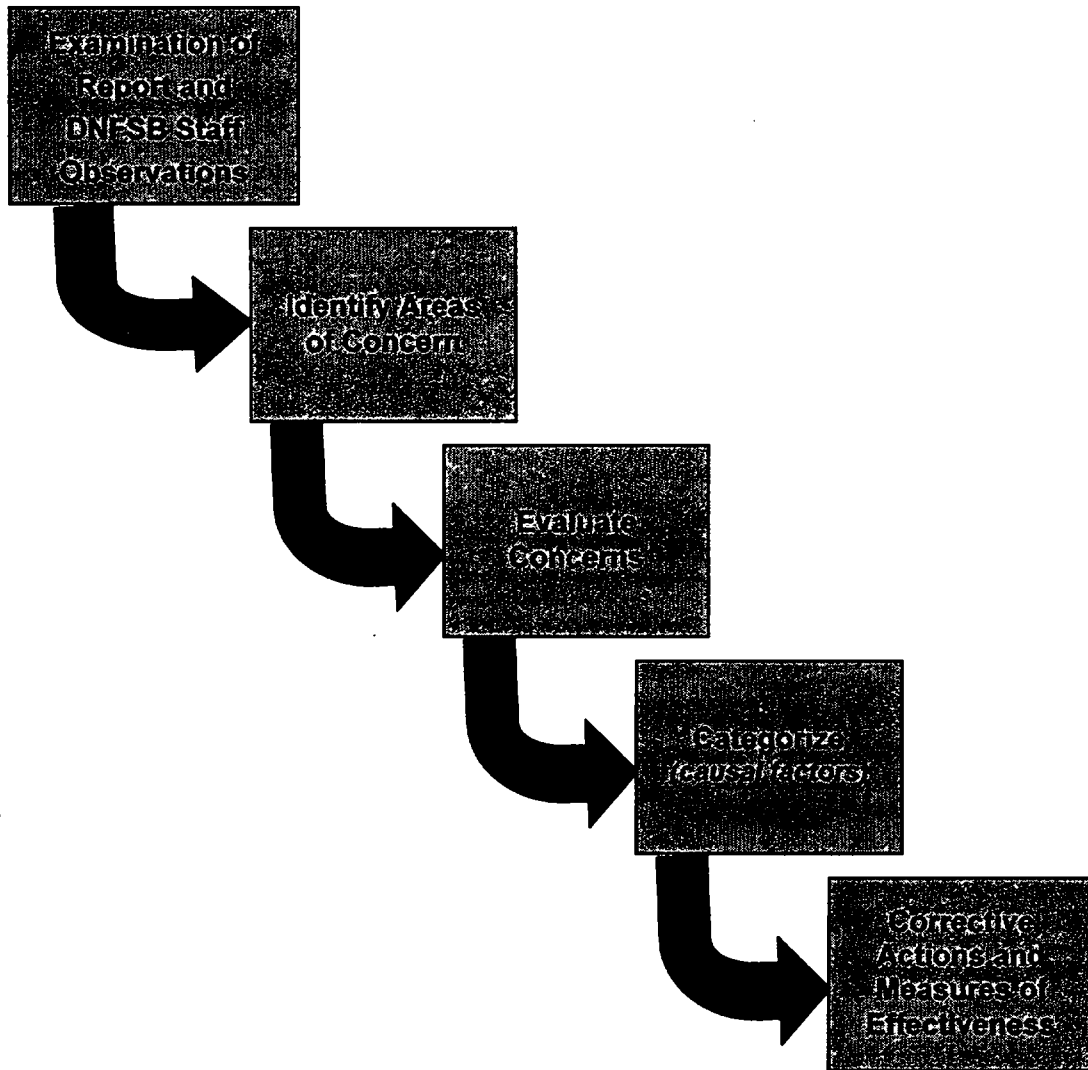
Figure 2-1. Corrective Action Methodology

The key process steps are illustrated in Figure 2-1. The CAP is provided in Section 8, *Corrective Action Plan*.
