URANIUM-233 STORAGE SAFETY  
AT  
DEPARTMENT OF ENERGY FACILITIES

Defense Nuclear Facilities Safety Board

Technical Report

February 1997

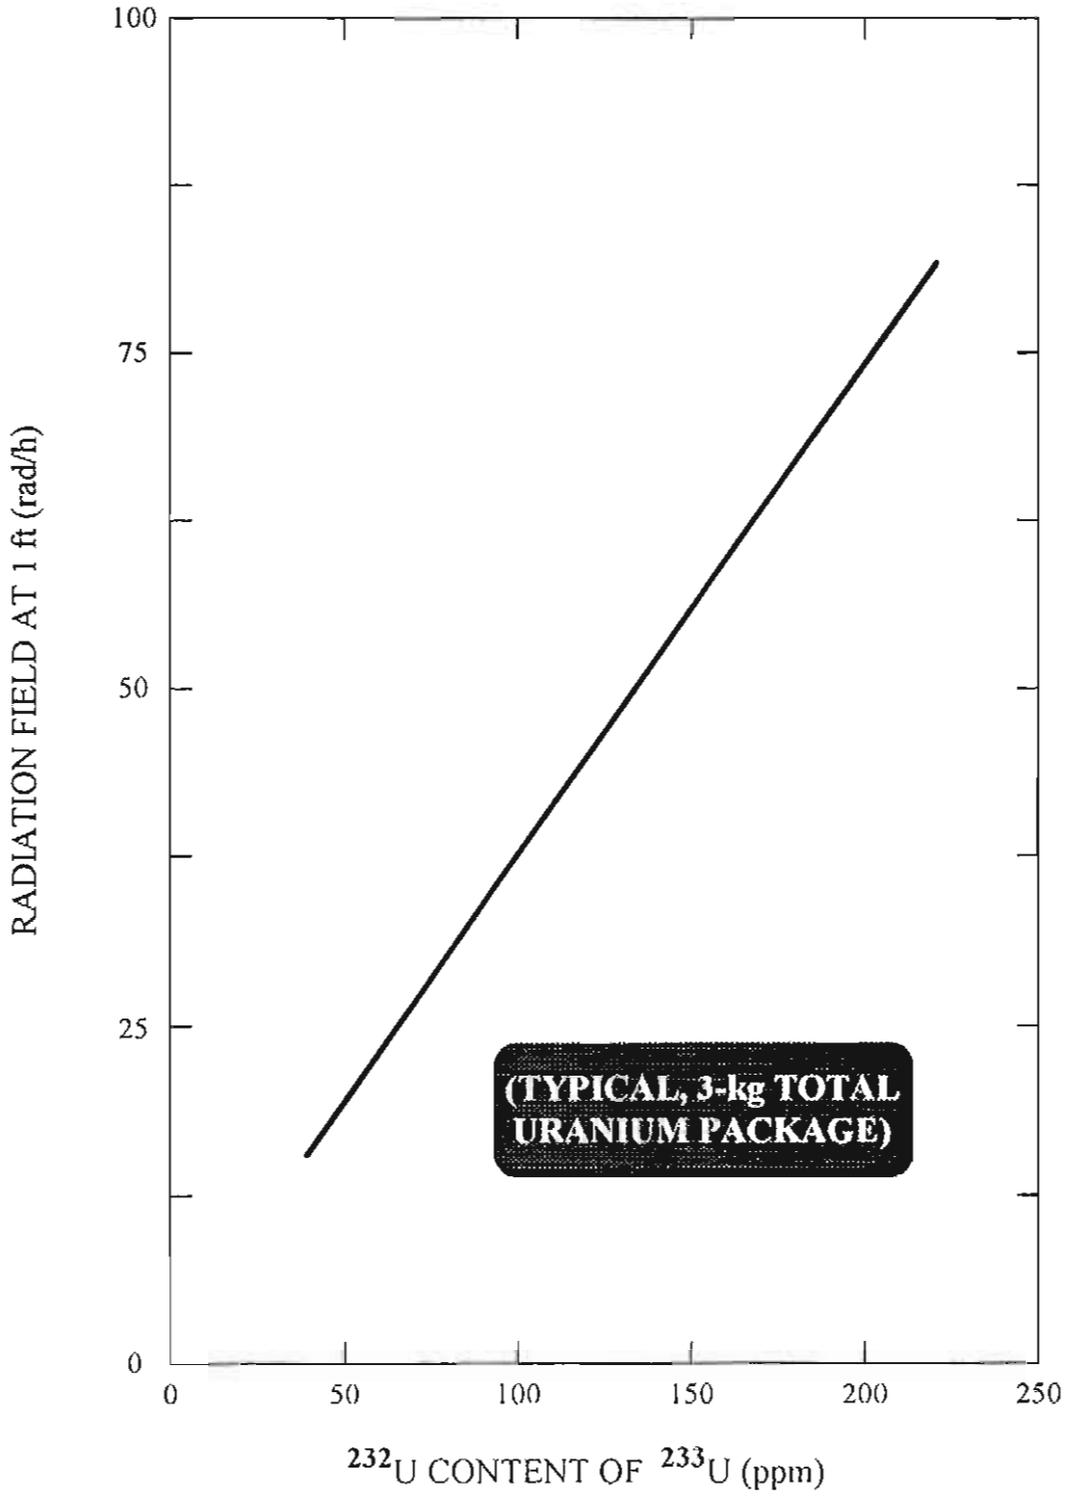
ORNL DWG 91A-414

APPENDIX C. RADIATION FIELDS ASSOCIATED WITH URANIUM-232 CONTENT
