**DEFENSE NUCLEAR FACILITIES
SAFETY BOARD**

Staff Report

April 7, 2022

Savannah River Site 296-H Tritium Stack Structural Review

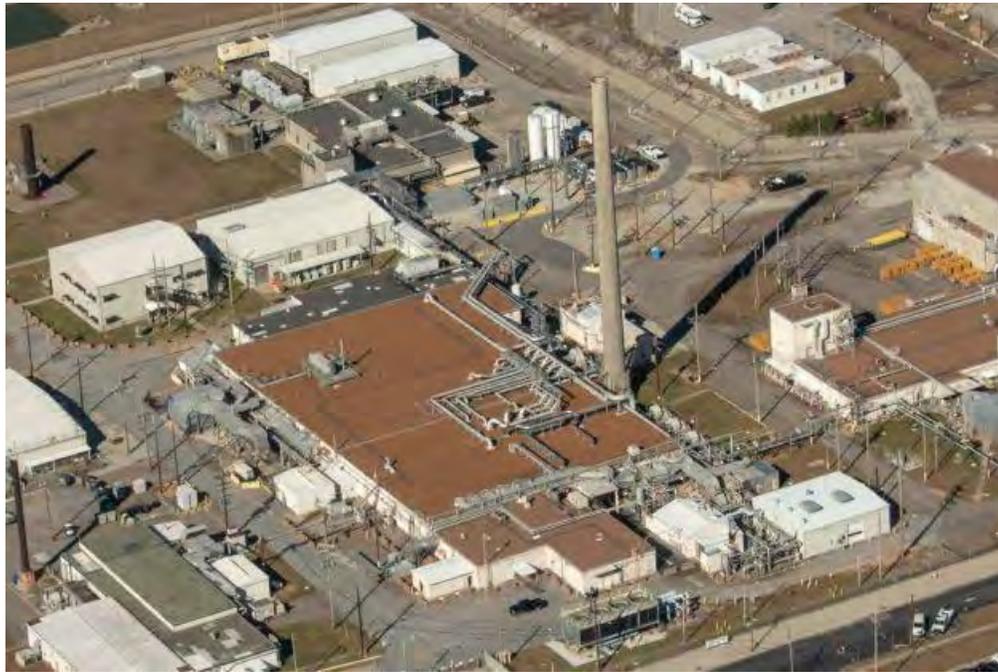
296-H Stack—The 296-H stack at SRTE was constructed in 1956 and is the primary ventilation exhaust stack for Building 234-H. The stack is located close to the east side of Building 234-H and is approximately 147 feet from the 217-H vault. The stack is 183’8” tall above its pedestal, and its outer diameter tapers from almost 13 feet at its base to 9 feet at the top. The stack and its pedestal are constructed of reinforced concrete and are founded on a 36-foot octagonal reinforced concrete mat. Regarding steel reinforcement for the stack, there is a single vertical layer along with a single layer of horizontal confining steel; the latter is configured as spiral rings with a six-inch pitch. Lastly, due to the non-caustic nature of effluent gases, the stack does not have an interior liner. An aerial photo of the 296-H stack next to Building 234-H is shown in Figure 1.

Figure 1. *Aerial View of 296-H Stack, next to Building 234-H, at SRTE*

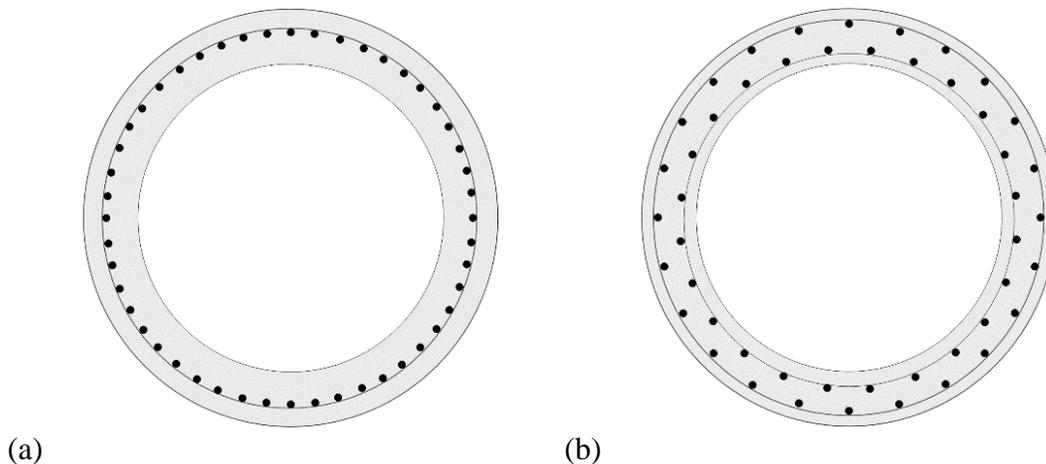
Single Reinforcement Design—Due to the vintage of the 296-H stack, it was designed with dated practices. In particular, the stack only contains one layer of vertical reinforcing steel along its length and only one layer of circumferential (confining) reinforcing steel in the horizontal direction. Figure 2 compares a single reinforcement configuration with a two-layer (“two-face”) reinforcement configuration. American Concrete Institute Standard 307-08, *Code Requirements for Reinforced Concrete Chimneys* [10], states the following in its commentary Section R4.1 (emphasis added):

*For the 1995 edition, the Committee re-evaluated the previous exemptions regarding two-face reinforcement and minimum wall thickness for chimneys 300 ft or less in height and less than 20 ft in diameter. Recent information has indicated that two-face circumferential reinforcement is necessary to **minimize vertical cracking** due to radial wind pressures and reverse thermal gradients due to the effects of solar heating.... [T]he current committee believes that two-face reinforcement should be required in all chimney columns, regardless of size, considering the **aggressive environment surrounding chimneys**.*

Figure 2. *Example Cross-sections for Vertical and Horizontal (“confining”) Reinforcement*
(a) *Single Layer of Reinforcement* (b) *Two Layers of Reinforcement (“two face”)*
[Note: These are not cross-sections of the 296-H stack]

Since SRNS does not inspect the interior of the 296-H stack, the presence of vertical cracks within the stack has not been determined. It is SRNS’s position that there are likely no

interior vertical cracks since they would propagate through the thickness of the stack and be seen on the exterior of the stack. However, the Board's staff notes that interior vertical cracks may not manifest themselves on the exterior of the stack due to the presence of confining steel surrounding the vertical reinforcement.
